# ROHM & HAAS COMPANY

REDSTONE ARSENAL RESEARCH DIVISION

Report No. S-16

Report of Fatal Explosion - March 28, 1958

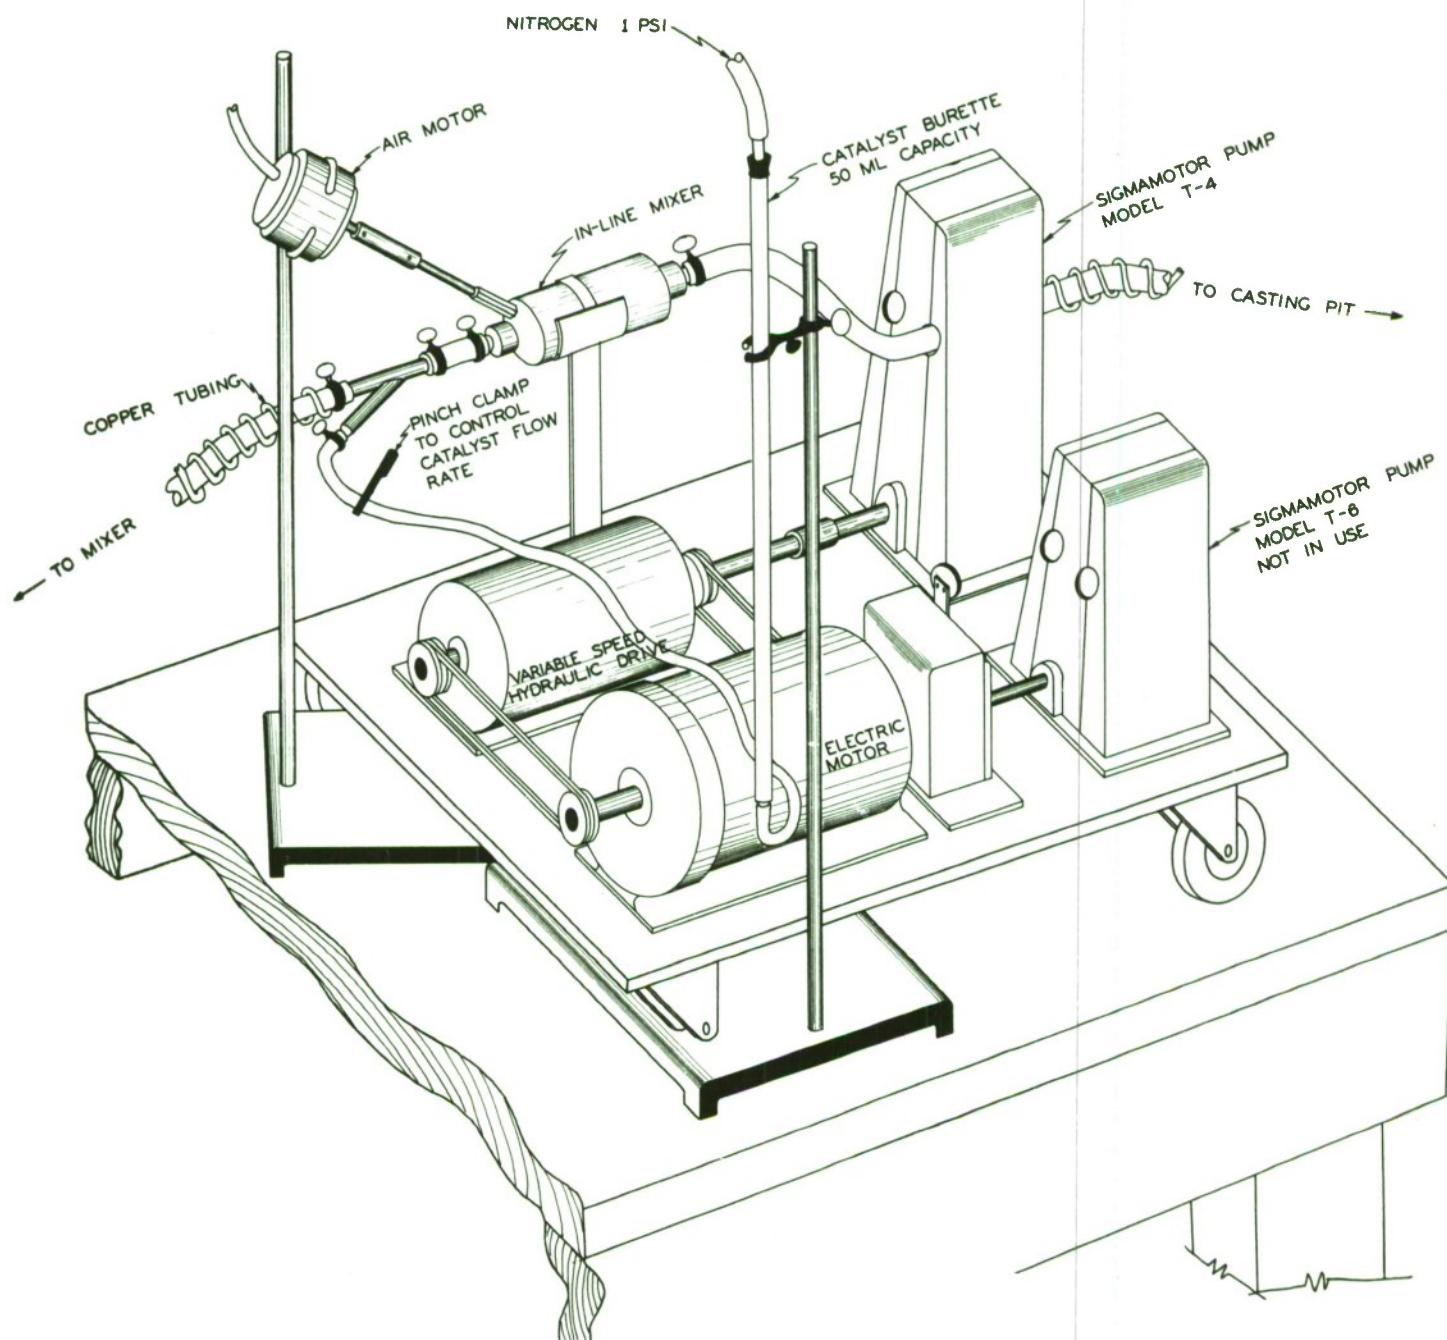
Fig. 3 Isometric of table top showing catalyst burette, in-line mixer, and Sigmamotor pump.

Corder had just entered the bay to help refill the catalyst burette and both Meinert and Corder were standing in front of the catalyst burette (Fig. 2). Meinert was apparently standing to the south and was probably turned partially toward Corder who was probably facing the table almost directly. They stood within two feet of the in-line mixer, though their attention was on the burette in front of the mixer.

the in-line mixer table is shown on Sketch B (Fig. 3). During the casting operation we kept the big kettle in operation at its lowest possible speed. This was done to prevent the material from settling. Propellant material was allowed to flow by gravity through a plastic line to the in-line mixer. The catalyst addition took place just prior to the in-line mixer as shown by the lines joining in Sketch B (Fig. 3). The catalyst burette was located at the front of the table and the rate of addition of catalyst could be adjusted by means of a pinch clamp. The catalyst burette was kept under about 1 psi of nitrogen pressure. The in-line mixer was driven by an air motor. This motor is not geared up in any way and produces very little torque. It could be stopped by grasping the shaft with your fingers. The in-line mixer itself had been drawn up by the Design Group of the Engineering Section from a sketch supplied by me. Its design is shown on Sketches C-1, C-2 and C-3 (Figs. 4 - 7). It had a Teflon sleeve inside to guard against the possibility of metal-to-metal contact between the inside of the mixer and the impeller and it had Teflon packing rings to prevent metal-to-metal contact with the stirrer shaft. Originally the packing ring follower had screwed into the head of the stuffing box of the in-line mixer. This permitted the assembly to be screwed in too tightly if you really bore down. When this occurred once a few days before the accident the stuffing box overheated. To correct this condition we had the Shop remove the threads and install two little shoulders which allowed the packing ring follower to be screwed to the mixer head. The modified assembly was supposed to prevent any excessive tightness in the stuffing box assembly. Also there was no longer a threaded joint in a position where there might be contact with propellant. I think the records will show that we had one run with the redesigned stuffing box before

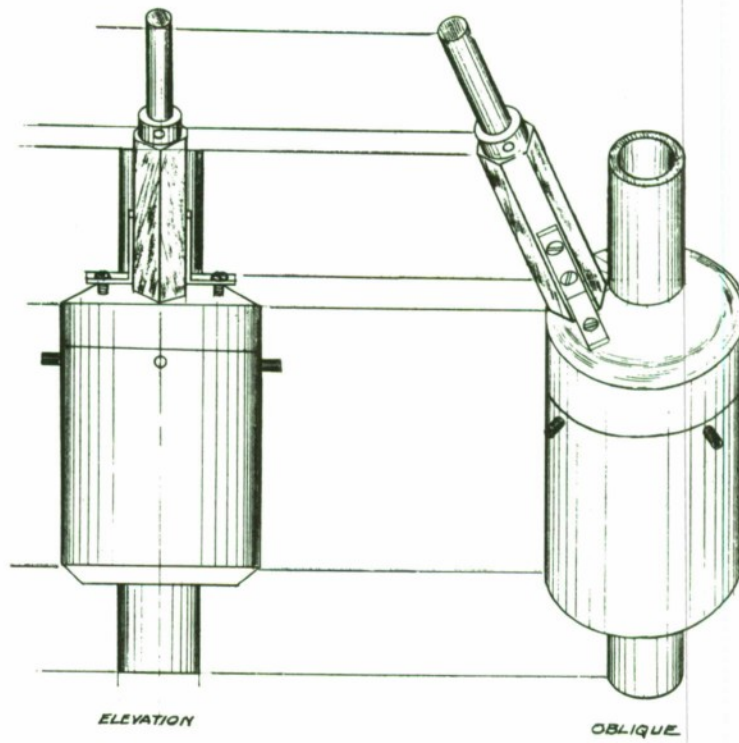
Fig. 4 External views of modified in-line mixer.

The in-line mixer (Figs. 4 - 7) was a cylindrical metal vessel having an inside diameter of 2 inches, length of approximately 4 inches, and a volume of approximately 10 cubic inches. The mixer was closed with an end cap held in position by two shear pins, and nipples were welded to each end to allow attachment of the hose. An impeller shaft was set into the head-end at approximately a 30° angle, and Teflon packings were used to prevent metal-to-metal contact. The impeller and shaft were made of stainless steel, and the interior of the mixer was lined with a Teflon sleeve to prevent metal-to-metal contact between the mixer and the impeller if the impeller shaft should become malaligned. In the original design of the in-line mixer the packing around the impeller shaft was tightened by screwing the gland into threads in the mixer head. However, an overheating had been noted at one time and there was also the possibility that propellant could enter the threads. Therefore, for safety, the male threads were cut off and two brackets attached by small screws to opposite sides of the hexagonal outer surface of the gland. One brass screw was inserted in the protruding part of each bracket and the gland tightened by screwing into blind threaded holes in the mixer head.
